Millstream Lodge - Case Study

CASE STUDY— Rickmansworth

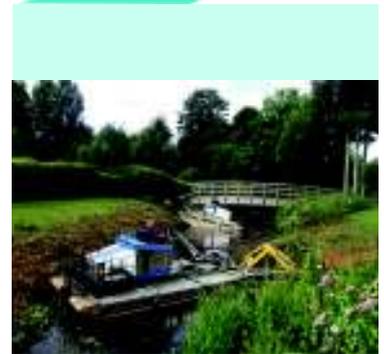
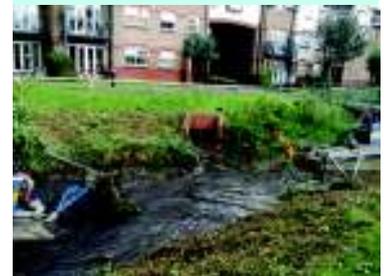
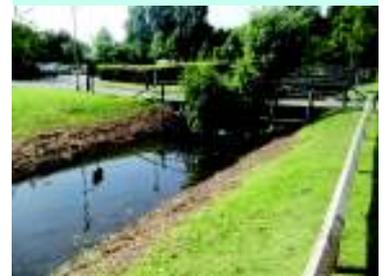
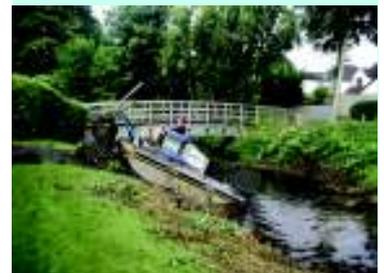
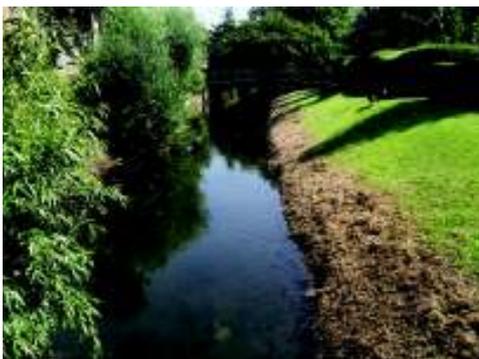
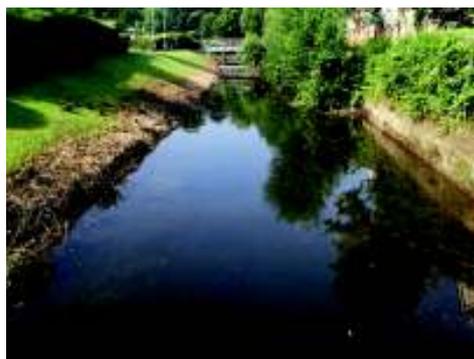
On completion of the job, the channel had been increased from 1-2 metres to 6 metres wide. The banks were left in a good condition thanks to the minimal weight and pressure exerted by the Truxor machines, and the fact that they were able to do most of the work on water in the stream.

The “after” pictures below show the cleared channel and the banks which strimmed of all vegetation to show the new waters edge.

The 2 sections of hedge that had to be removed were then trimmed, replanted into the gaps and watered to allow the hedge a chance to recover. The slipways that were used for the Truxor and mini excavator were cleaned and levelled to allow the grass to recover and any re-seeding to be done if required.

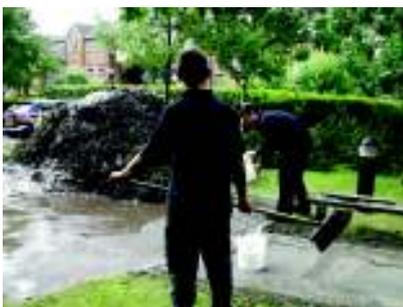
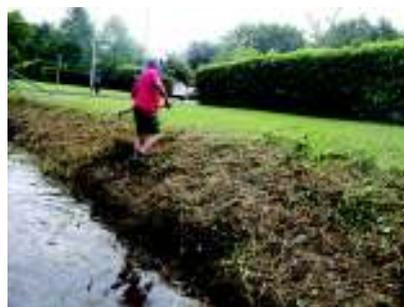
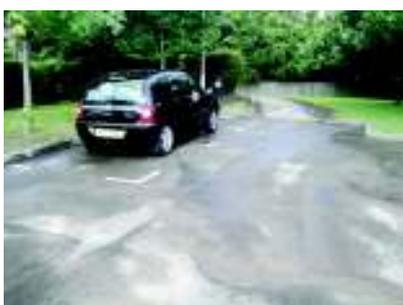
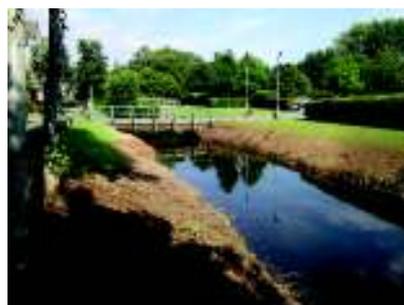
Pictures below show cleaning down the car park and raking the banks after brushcutting to remove all of the loose vegetation to leave them looking tidy.

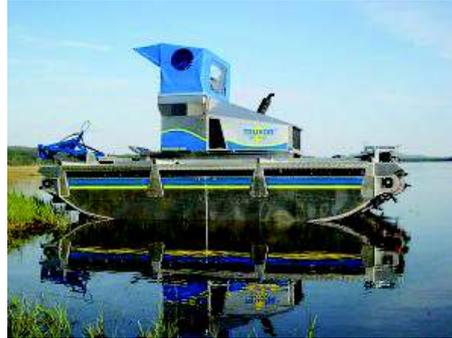
The **Amphibious Truxor Machine** is an extremely lightweight, manoeuvrable vehicle, capable of working in the tightest and most challenging of aquatic environments.

Able to turn on its own axis and weighing less than 1,400 kg it is ideal for SSSI sites, golf courses, stately homes, private properties and public parks. It leaves little more than the mark of a human footprint, ensuring restorative work on project completion is minimal.

The Truxor's ability to work on or off water makes it ideal for a site where public access cannot be limited or where larger terrestrial machines are not suitable. With a wide range of tools available it is ideal for a variety of tasks within the water. The machine is transported on a flatbed trailer towed by a 4x4 vehicle, overcoming problems with access encountered when using heavy plant and machinery.
