Business Park, Chertsey - Case Study

CASE STUDY— Chertsey

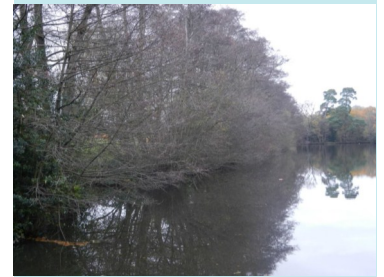
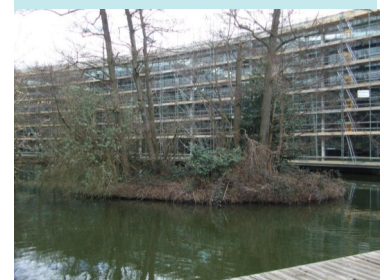
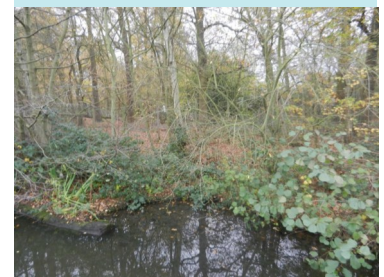
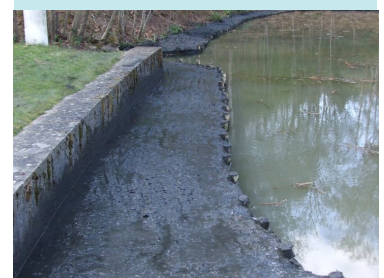
As the key focal point from the glass fronted building, the lake on the site was suffering from lack of maintenance. The overgrown trees had low branches over the water and the mass of rotting leaves had led to a build up of silt at the bottom of the lake. The pictures on the right show the site before work took place.

The inflow and outflow of the lake were positioned in such a way that a large proportion of the lake did not benefit from the movement /flow of water, and had therefore become stagnant.

Trees were the first thing to be addressed; they were pruned and shaped, and low branches overhanging the water were removed, in order to reduce the debris falling into the lake and to enhance aesthetics. Weeds, brambles and unwanted vegetation were cleared from the banks.

Nicospan fencing was installed inside the existing border of the lake. Nicospan is a lightweight, permeable membrane ideal for vertical bank protection/creation. The fabric allows water to flow out, but retains soil, and allows the establishment of vegetation making it environmentally desirable.

The membrane has pockets through which posts can be inserted, and the posts are then driven into the bottom of the lake bed.

The shaping of the fence was carefully planned ensuring the flow of water was of benefit to all parts of the lake, and removing the issue of stagnant areas.

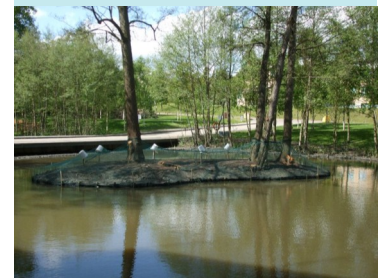
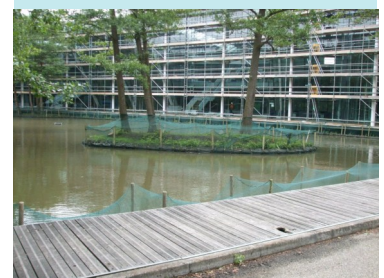
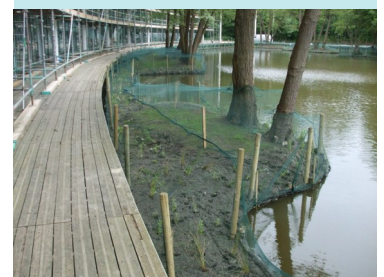
The photographs on the right show the results of the work. Trimmed trees, cleared weeds, and newly planted banks - protected with netting while the plants become established. Both flora and fauna will flourish when the marginal plants have established.

The next phase of the project was to extract the build-up of silt from the bottom of the lake.

The **Truxor DM5000** machine, with a clamshell (bucket) attachment was used by the Aquatic Solutions team to excavate the silt and deposit it behind the Nicospan to create new banks, recycling the material and saving the huge cost of removal from site.

The **silt** is made up of decomposed organic material, making it nutrient rich and an ideal compost ready for the next phase of the project — planting. Marginal plants including Canary Reed Grass, Common Reed, Bulrush, Purple loose strife, Water Mint, Iris, Pond Sedge, Hop Sedge, Soft Rush, Marsh Marigold and Water Forget-me-not were planted and protected from wildlife predation with the use of bird netting. Once the plants are established, the netting will be removed and these areas will further enhance the aesthetics of the lake.

Aeration was improved with the installation of three fountains which will help keep the water oxygenated and finally, **water lilies** were planted to ensure some shade and protection for the fish and aquatic amphibians in the lake. The lilies will also become an attractive feature of the lake once established.

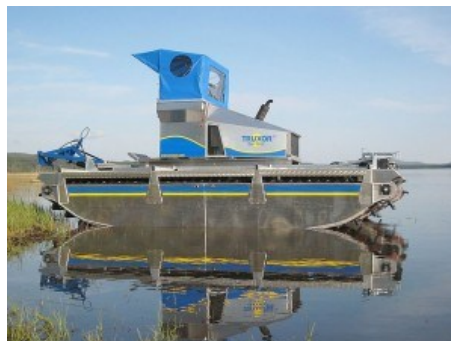
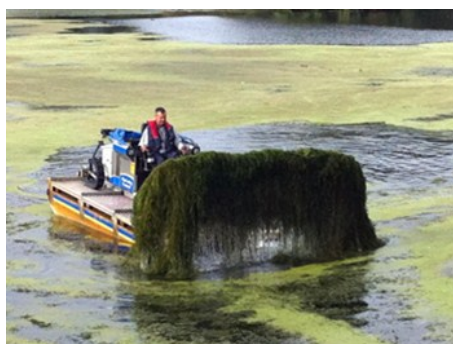
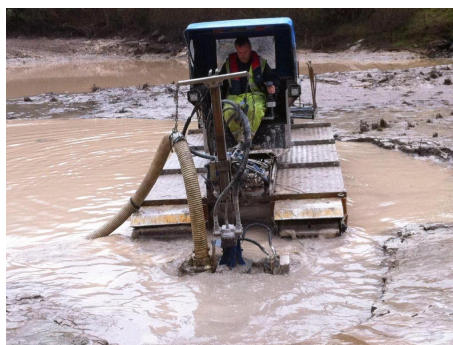
The **Amphibious Truxor Machine** is an extremely lightweight, manoeuvrable vehicle, capable of working in the tightest and most challenging of aquatic environments.

Able to turn on its own axis and weighing less than 1,400 kg it is ideal for SSSI sites, golf courses, stately homes, private properties and public parks. It leaves little more than the mark of a human footprint, ensuring restorative work on project completion is minimal.

The Truxor's ability to work on or off water makes it ideal for a site where public access cannot be limited or where larger terrestrial machines are not suitable. With a wide range of tools available it is ideal for a variety of tasks within the water. The machine is transported on a flatbed trailer towed by a 4x4 vehicle, overcoming problems with access encountered when using heavy plant and machinery.
