Breathing New Life Into Your Water Course

CASE STUDY— Earth Centre

The Solution—Large Lake

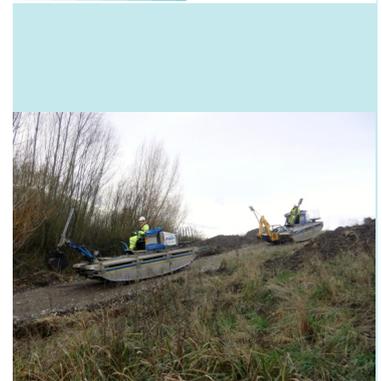
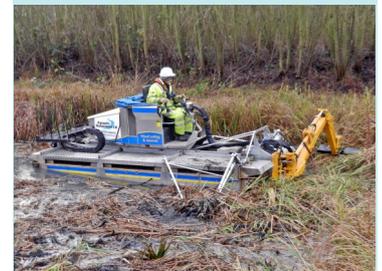
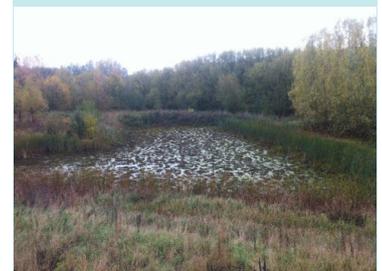
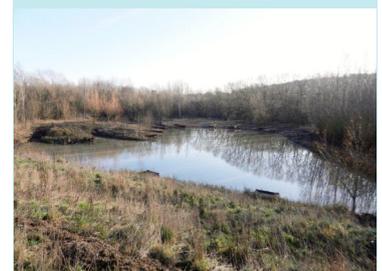
Aquatic Solutions were able to use two of their lightweight Truxor DM 5000 amphibious machines to gain access to the water, clear the vegetation from the large lake and clean the pond areas to restore them to their intended condition. There was a dense covering of water soldier present in the lake which first had to be removed, this was done efficiently and cleanly with the amphibious Truxors.

A mini digger was used to create a sump along side the edge of the lake for the undesirable vegetation to be deposited into. After leaving it on the banks for 48 hours to allow any Fauna to return to the water, it was then buried below ground level to naturally decompose. The original soil was then spread over the top to leave the area level and tidy.

An old stone channel provides an overflow into the neighbouring River Don. This had become overgrown and blocked. The team scraped out all of the vegetation and soil, and then incorporated it into the surrounding landscape. Handwork completed the tidying up the sluice gate, stone work and the over hanging trees.

The two boats were used in tandem, one had the excavator attachment fitted for removing the Phragmites and Bulrush rhizomes, while the other had the collecting rake attached, enabling them to work efficiently together on clearing the lake.

The excavator attachment on the Truxor was used and the process of digging out Bulrush and Phragmites around the entire perimeter of the lake commenced. The other boat begun clearing all of the floating Water Soldier from the lake followed by the floating reed and rush rhizomes, which had been pulled out and then allowed to float.

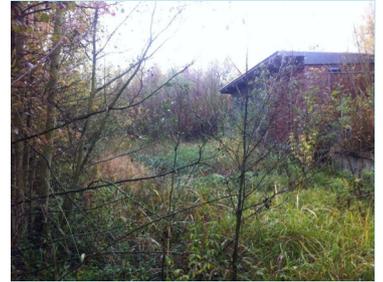
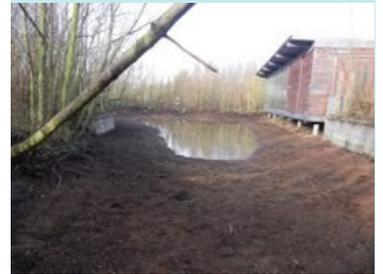
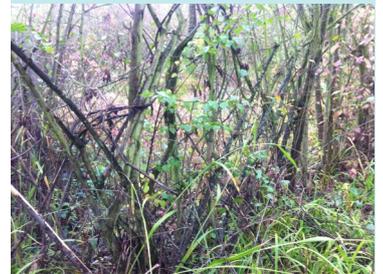
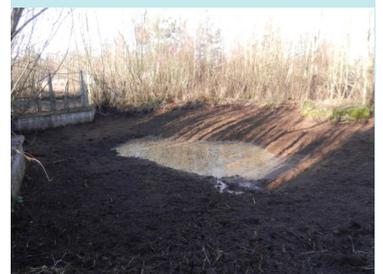
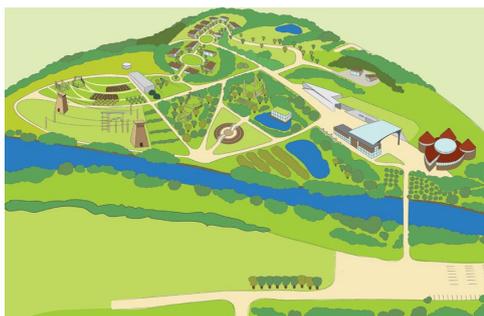
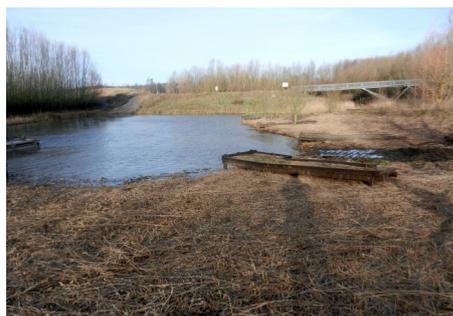
Water was almost non-existent in the small ponds due to overgrown vegetation taking over. The vegetation was pulled up by the roots using the clamshell attachment on the Truxor. The mini digger was used to remove volunteer saplings and to grade the base of the pond restoring it to its original shape. All the vegetation removed from the two ponds was taken away and composted onsite. Water was visible in both ponds almost immediately and they would soon be a thriving and complete pair of ponds. With the channels between the ponds, lake and river all clear, high water levels could be managed with flow possible through each of the water courses and into the River Don.

Kingswood opened the new Dearne Valley Activity Centre, one of the largest outdoor learning facilities in the UK, in Spring 2012. The educational ponds have been populated and will be used for pond dipping and wildlife observing and the large lake is clean and ready for the planned leisure activities to take place www.kingswood.co.uk/centres/dearne-valley .

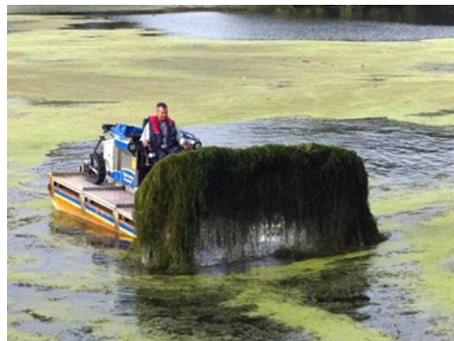
The Amphibious Truxor machine is an extremely lightweight, manoeuvrable machine capable of working in the tightest and most challenging of aquatic environments. Able to turn on its own axis and weighing less than 1,400 kg it is ideal for SSSI sites, golf courses, stately homes, private properties and public parks. Its ability to work on or off water makes it ideal for a site where public access cannot be limited or where larger terrestrial machines are not suitable. With a wide range of tools available it is ideal for a variety of tasks within the water. The machine is towed by a 4 x 4 on a flatbed trailer and the Truxor can drive itself to the water over the land.

- **Engine:** Daihatsu 35 hp diesel, Environment Class Euro 2
- **Dimensions:** Length 4.7 m, Width 2.06 m, Height 2.1 m
- **Hydraulic oil:** Biodegradable

- Cutter Basket
- Large Cutter Bar
- Heavy Duty Cutter
- Collection Rake
- Clamshell Bucket
- Silt & Dredge Pumps
- Excavator
